Repairing TRITTON Kunai Left Speaker

This guide will walk you through repairing the left speaker on your headset if our troubleshooting page proved insufficient. Please follow these instructions carefully and soon your speaker will be working.

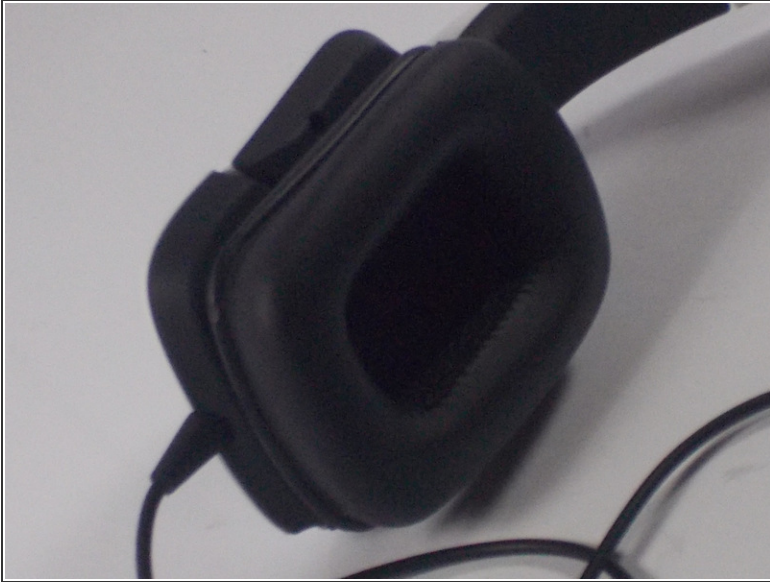
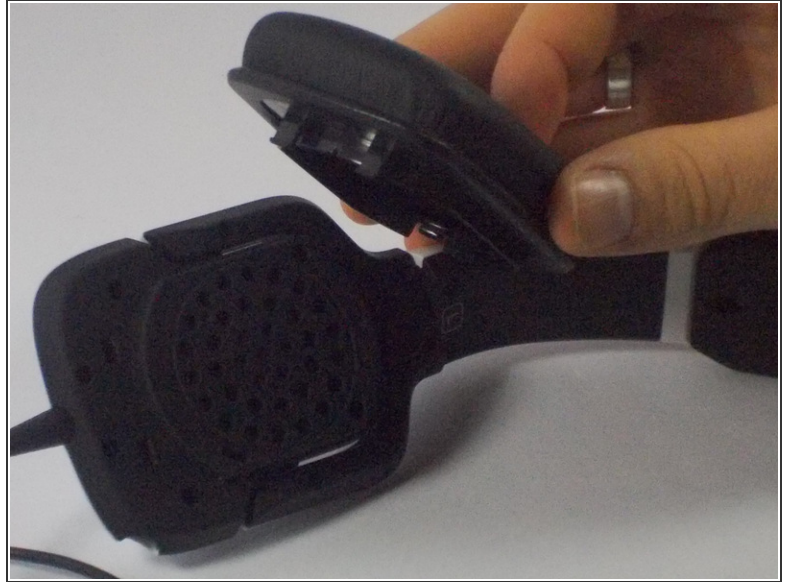
Step 1 — Repairing TRITTON Kunai Left Speaker

- Firmly grasp the black ear cushion with one hand and the white speaker frame with the other hand.
- Forcibly pull the ear cushion and speaker frame in opposite directions, until the left ear cushion separates from the left ear frame.

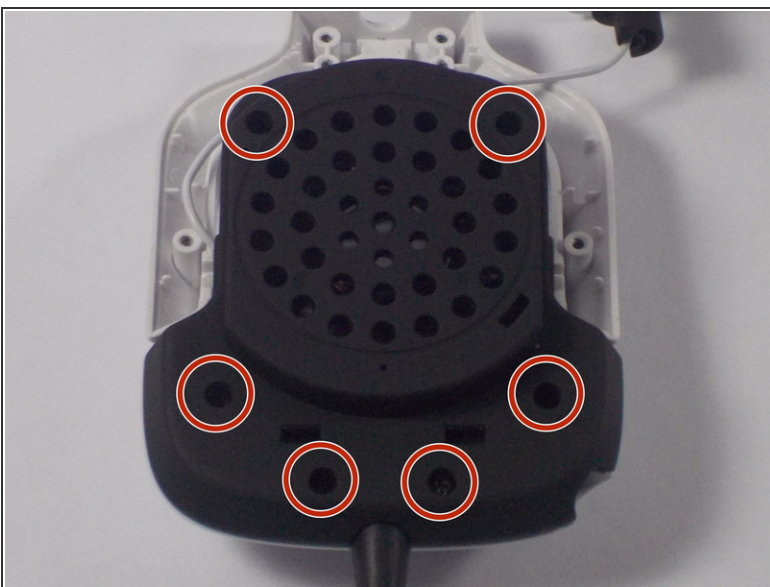
Step 4

- Remove the six 7 mm screws indicated in red using a PH00 screwdriver.
- Separate the black speaker console from the left speaker frame.
